Research report No.MRS 22

Characterization of tunnel segment fire behavior – Use of non-destructive technics

Authors: Pierre Pimienta - CSTB
Benoît-Louis Marie-Jeanne - CSTB
Roberto Felicetti – Politecnico di Milano

Two twin tunnels have been constructed to cross the Suez Canal in Egypt, one at Port Said near the North entrance of the Suez Canal and one at Ismailia city in the midst of the Canal.

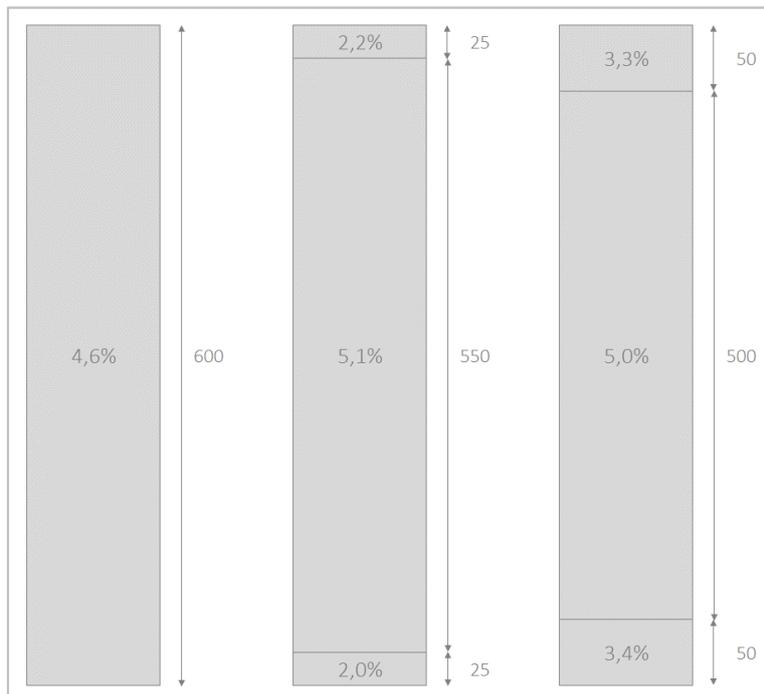
In order to determine the water content profile versus the depth, part of the cylinders has been cutted without water cooling. The lengths of the cutted samples are given in Figure 1.

Figure 1: Water content of the cylinders (ref DL09) and their cutted samples

Water content measurements of concrete pieces and cylinders are respectively reported in Figure 1 and in Figure 2.

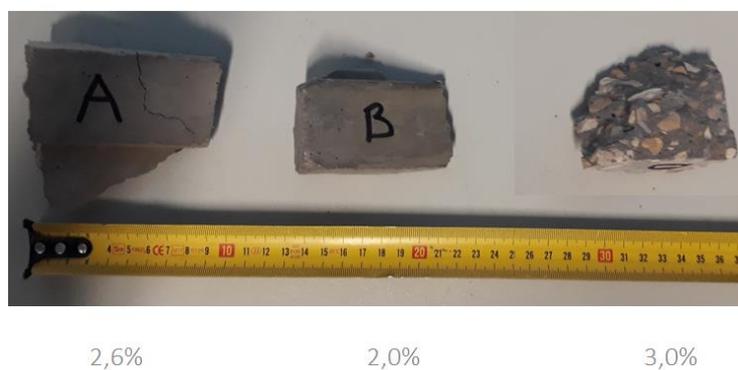
Figure 2: Water content of concrete pieces detached from the segment corners

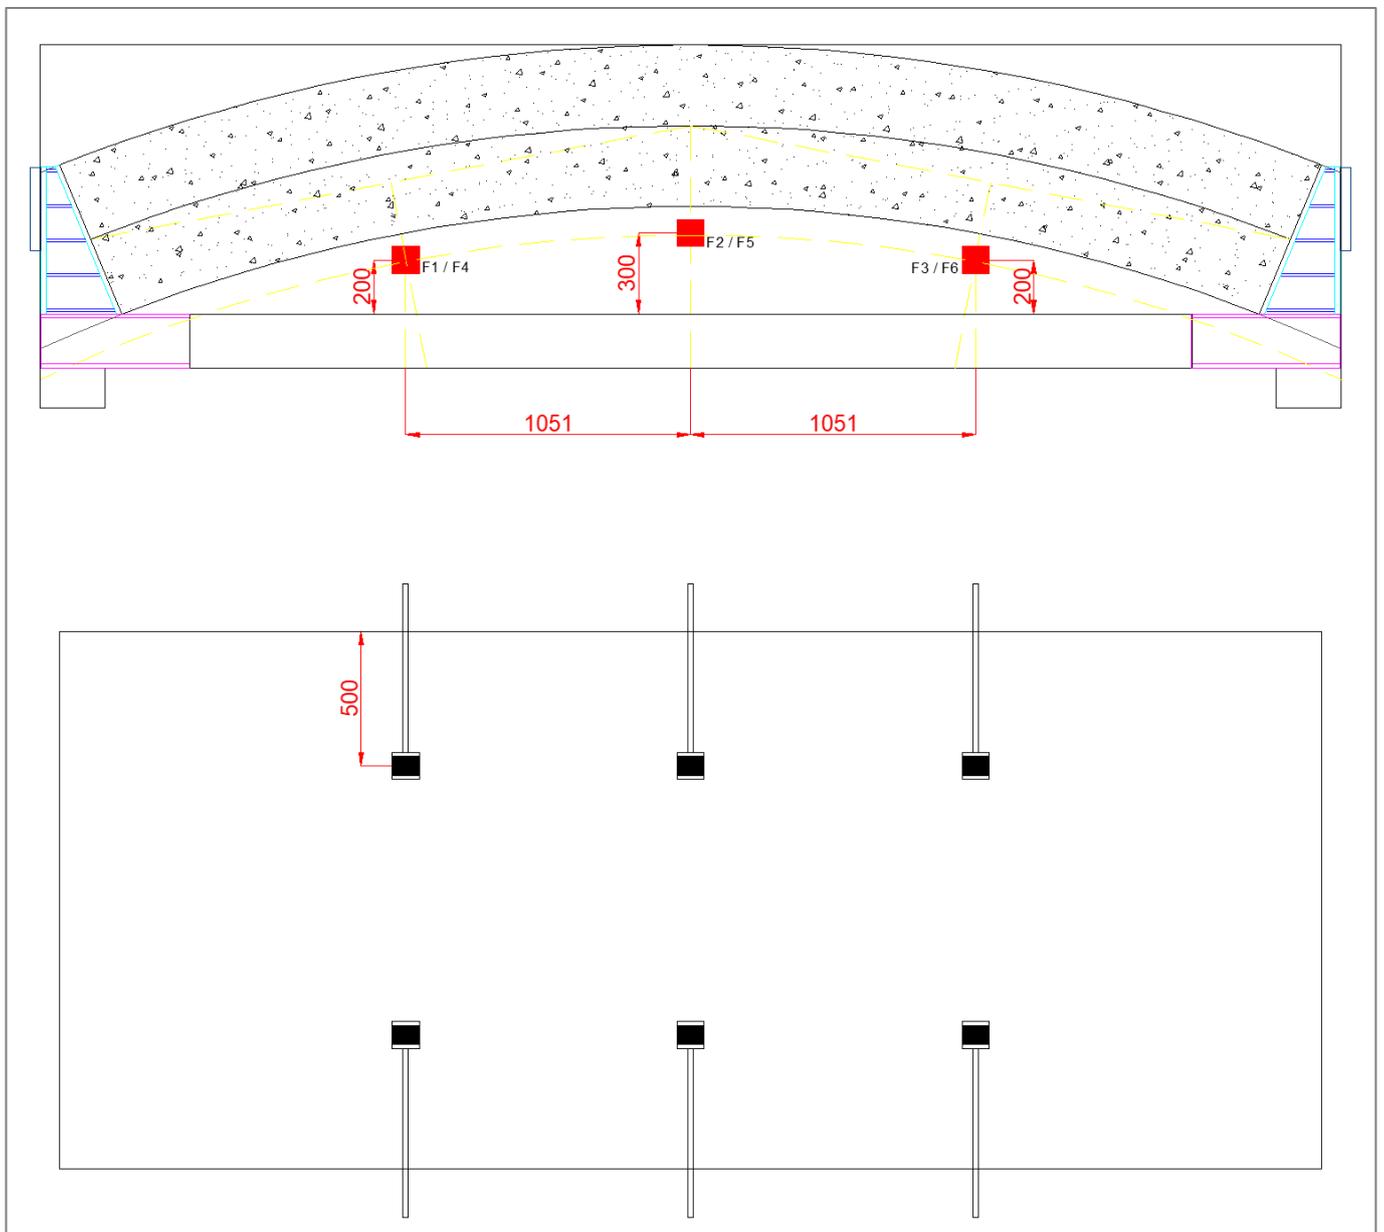
The temperatures are measured by using six plate pyrometers and recorded during the test, in accordance with standard NF EN 1363-1 paragraph 9.1.1 [5].

Figure 3: Location and identification of the plate pyrometers

Positions and identification of temperature measurements are given in Figure 3.

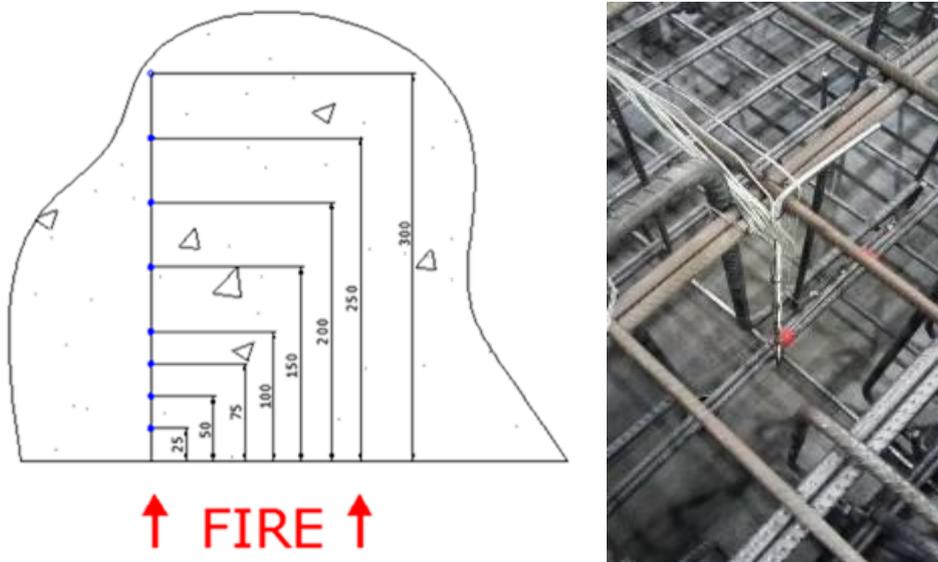
The series of 8 thermocouples have been beforehand assembled along a thin metal rod.

On site, the thermocouples were tied to the steel reinforced bars in order to impede their movement into the concrete formwork during the mold filling. The outer parts of the thermocouples were assembled in plastic bags.

Figure 4: Drawing and picture presenting the position of the K type thermocouples at different depths from the exposed surface

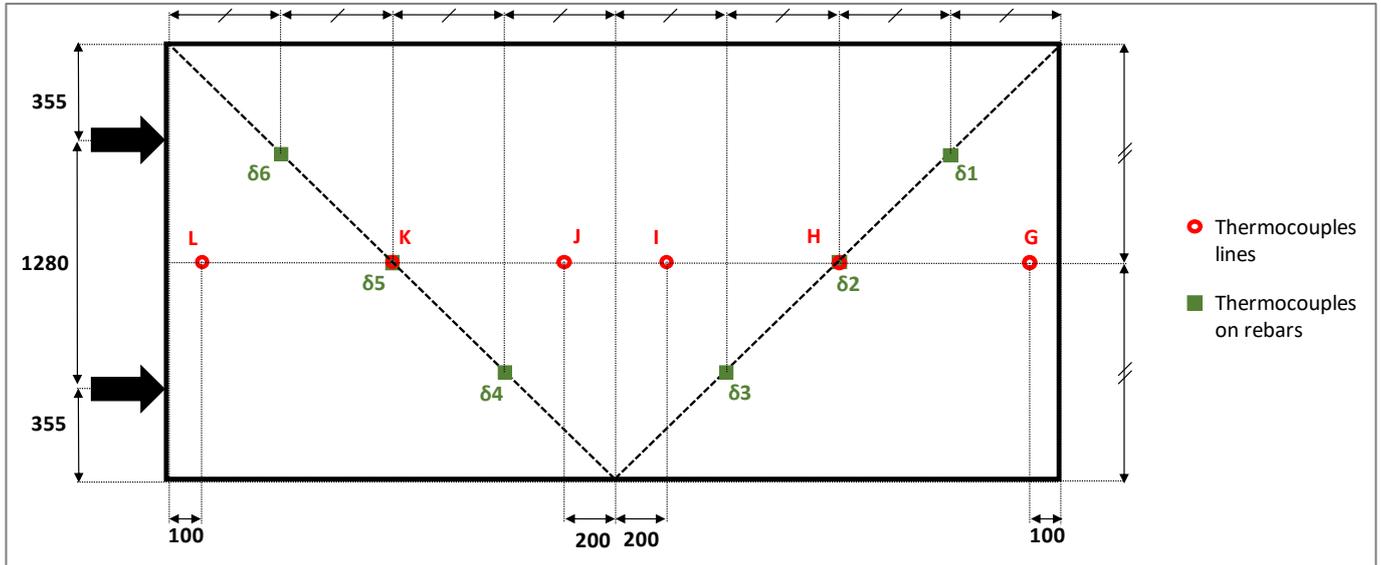
Figure 5: Top view – Location of the inner thermocouples

Location of the thermocouples is given in Figure 5, Figure 6 and in the appendix B page 17.

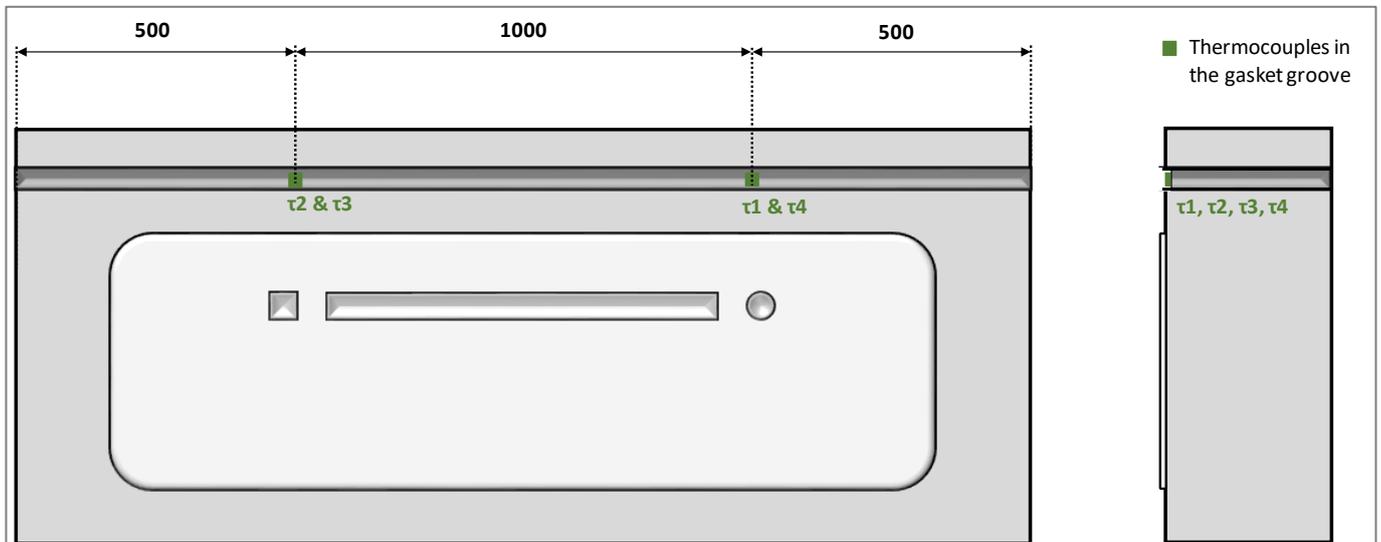
Figure 6: Front view – Location of the thermocouples at the boundaries of the single segment

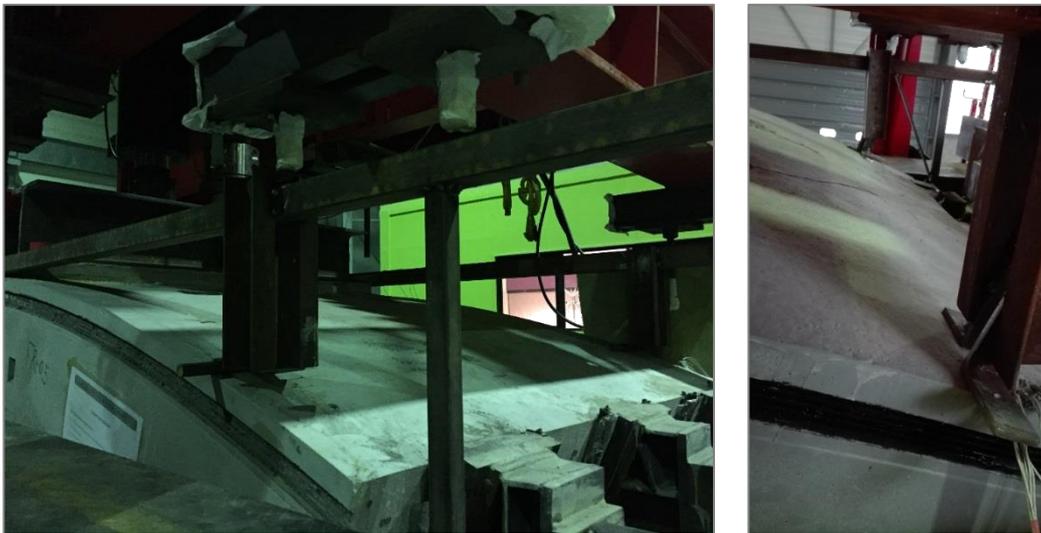
Deflection is measured in accordance with standard NF EN 1365-3 [6]. The frame used to hold the vertical displacement is shown in Figure 7 with the rolling and fixed contacts. Rolling and fixed contacts are located at 85 mm from the edge of the segment.

Figure 7: Rolling (left) and fixed (right) contacts of the frame used to measure the vertical displacement

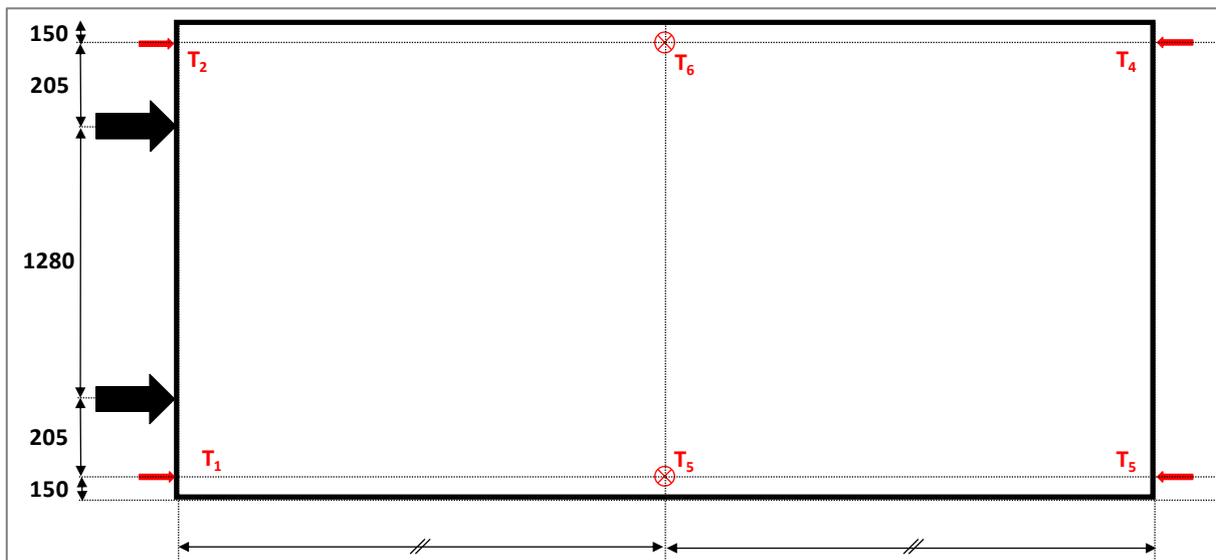
The position of displacement sensors are presented in Figure 8, Figure 9 and Figure 10. Horizontal and vertical displacement are denominated T1 to T4 and T5 to T6 respectively.

Figure 8: Top view – Displacement sensors locations

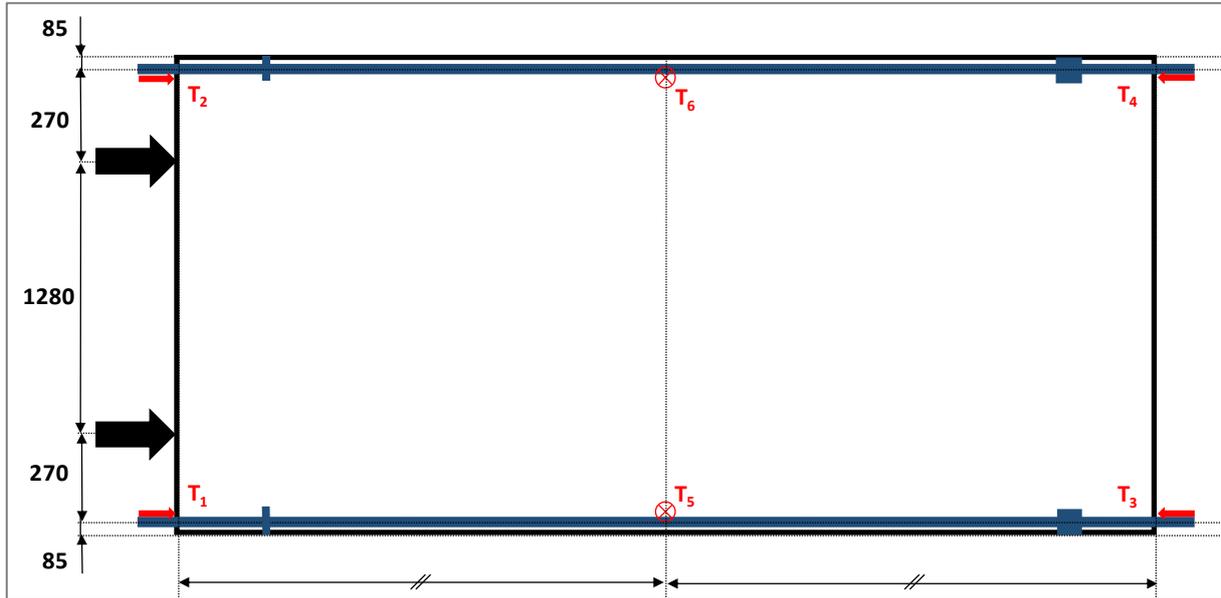
Figure 9: Top view – Displacement sensors locations with the two supporting frames

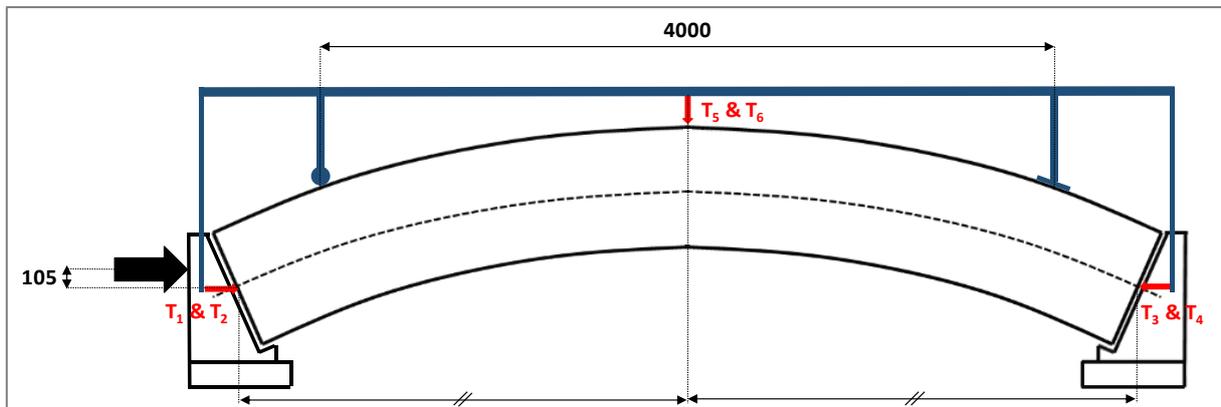
Figure 10: Top view – Displacement sensors locations with the two supporting frames

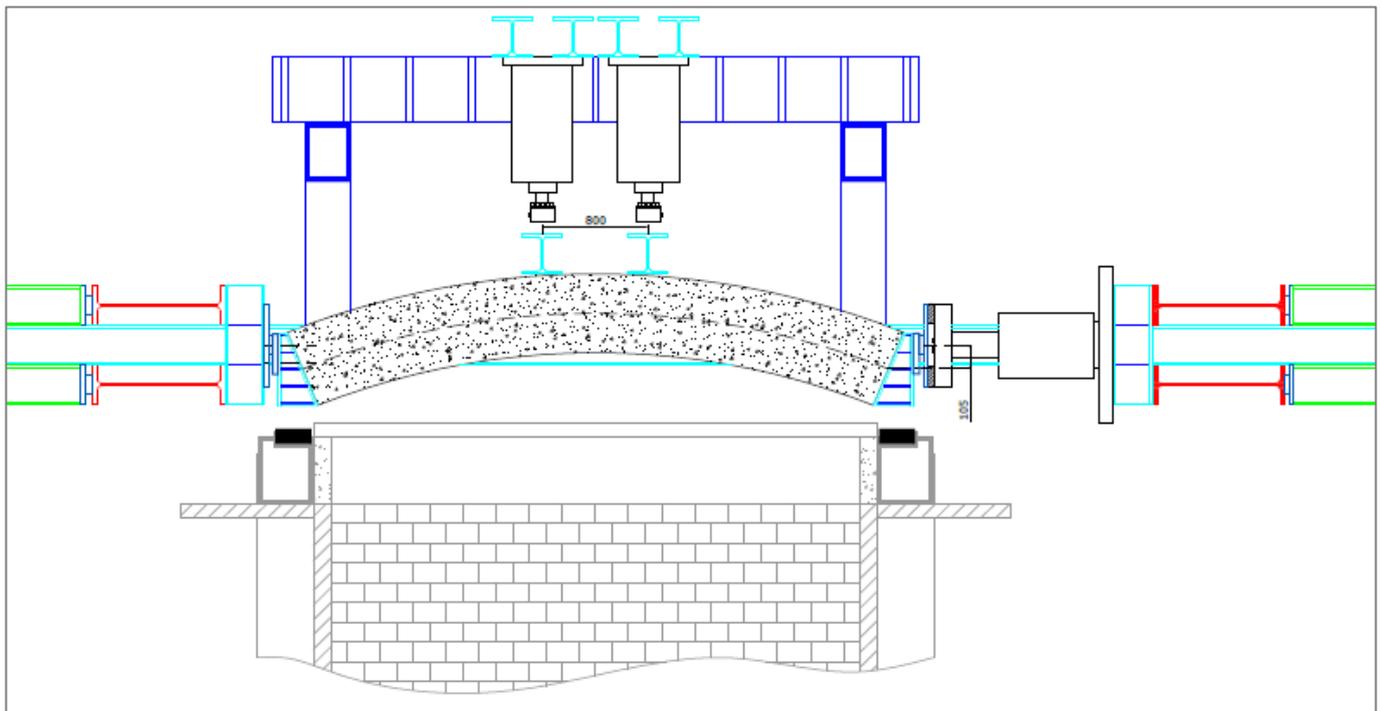
Mechanical loading equipment is represented in Figure 11, Figure 13 and Figure 15. It consists in:

- one horizontal frame with two 4 500 kN jacks;
- one vertical frame with two vertical 2 000 kN jacks.

Figure 11: Sectional view of the equipment (furnace and loading system) and the sample

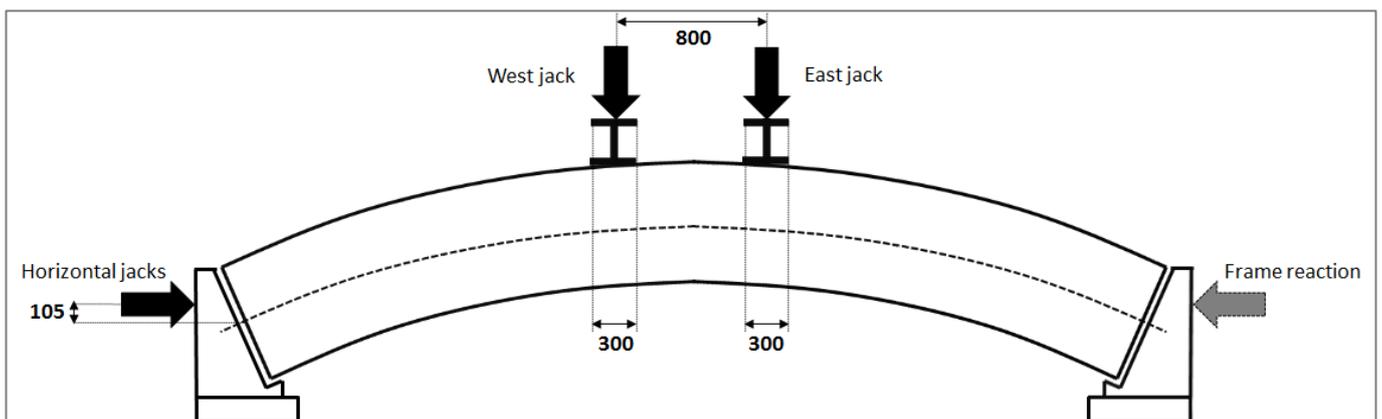
Figure 12: Sectional view of the loading system and the sample

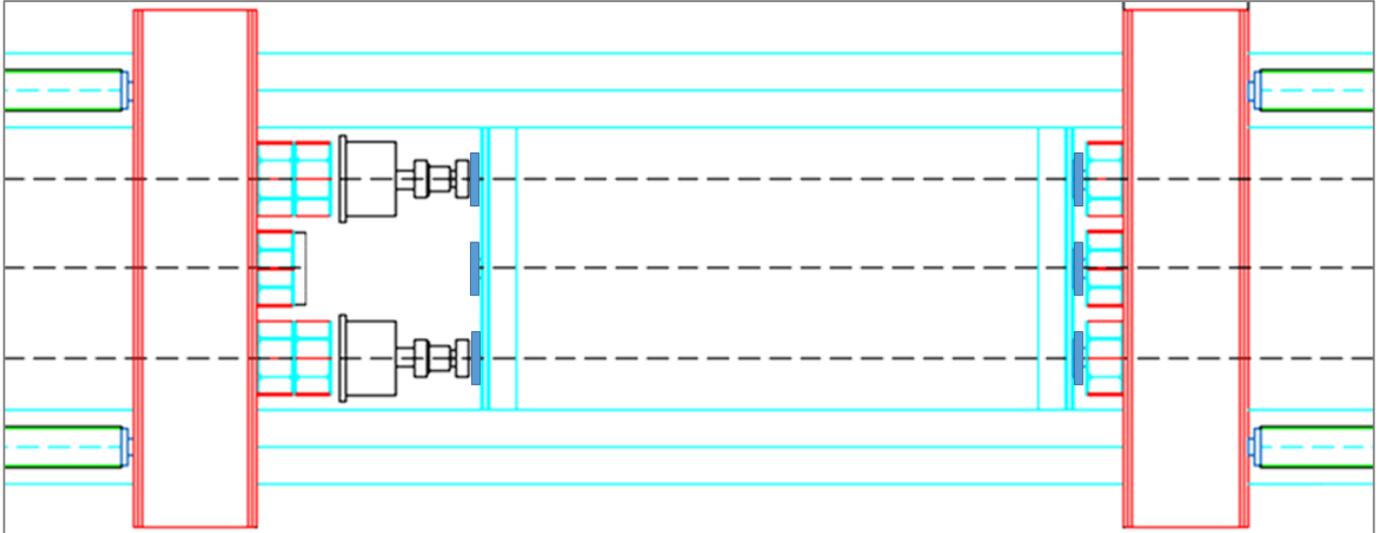
Figure 13: Top view of the equipment (furnace and loading system) and the sample

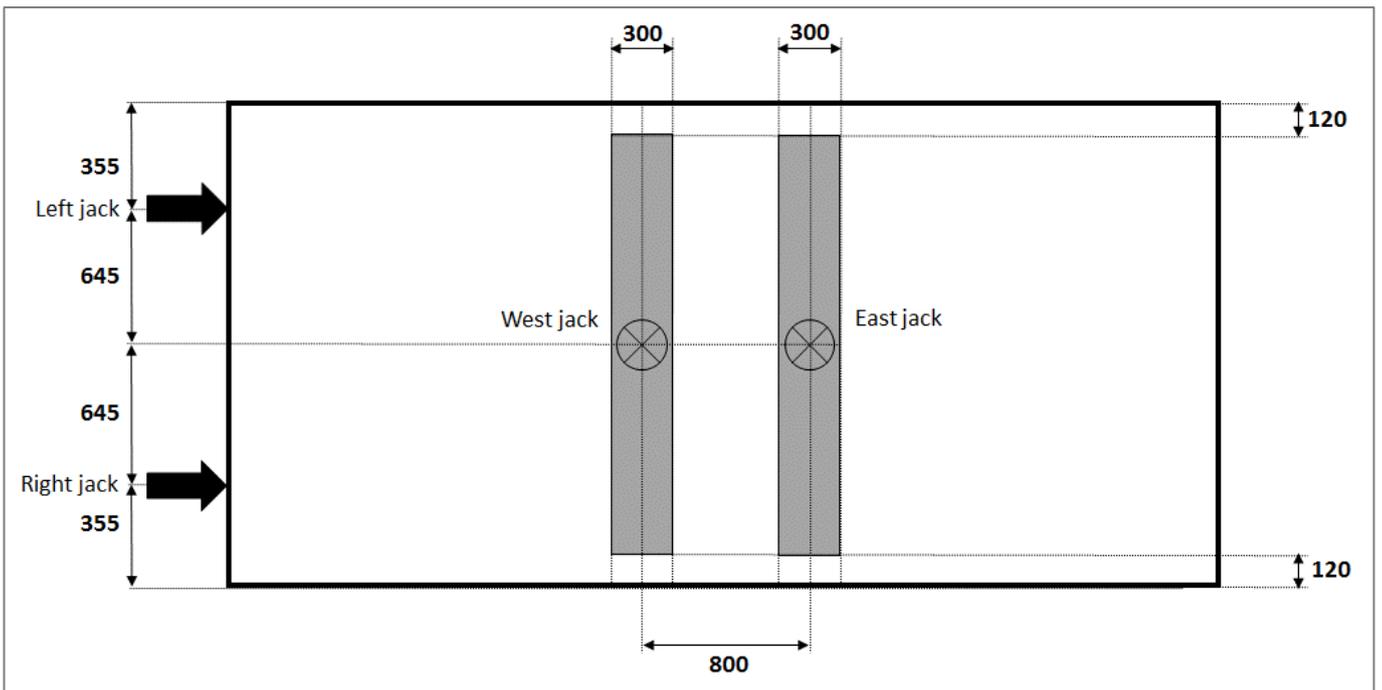
Figure 14: Top view of the loading system and the sample

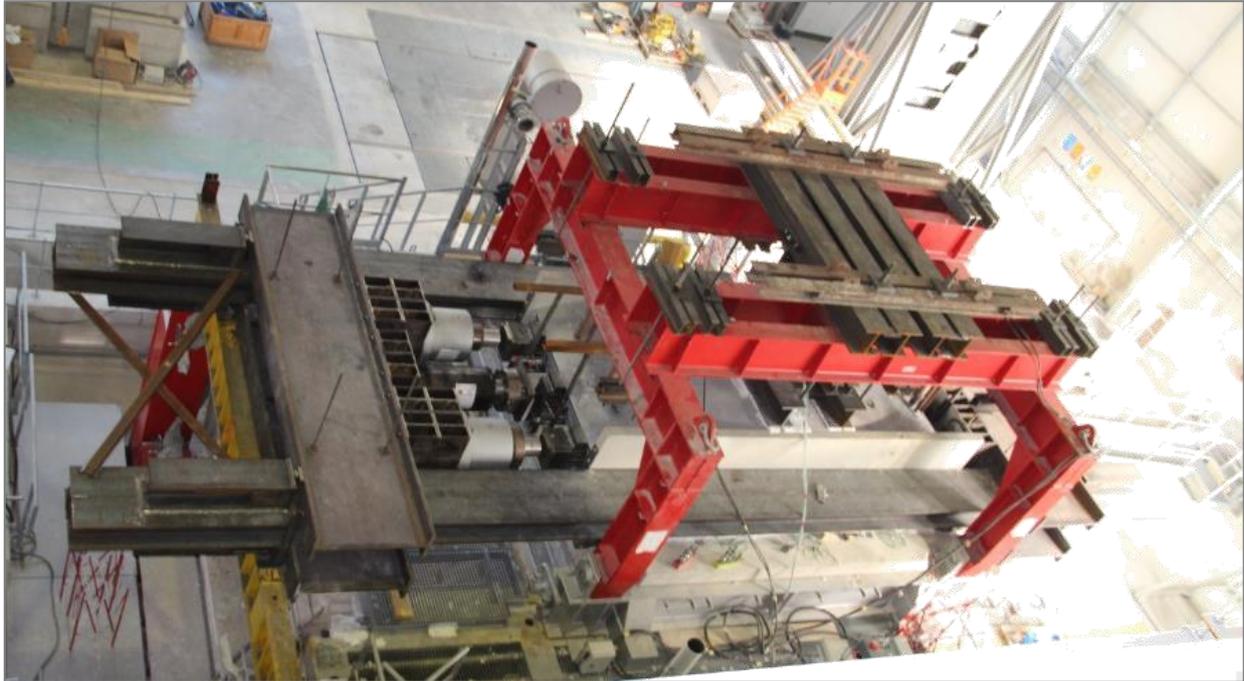
Figure 15: Picture of the whole equipment and the sample

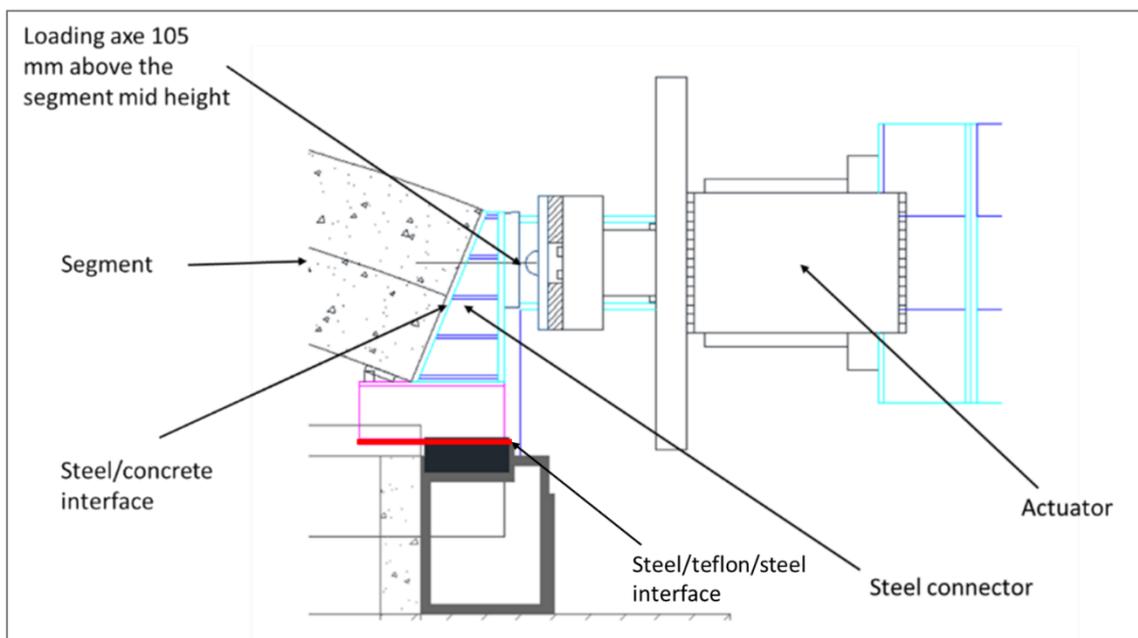
The geometry of the mechanical system from the actuator to the segment is presented in Figure 16.

Figure 16: Mechanical system to apply the horizontal load

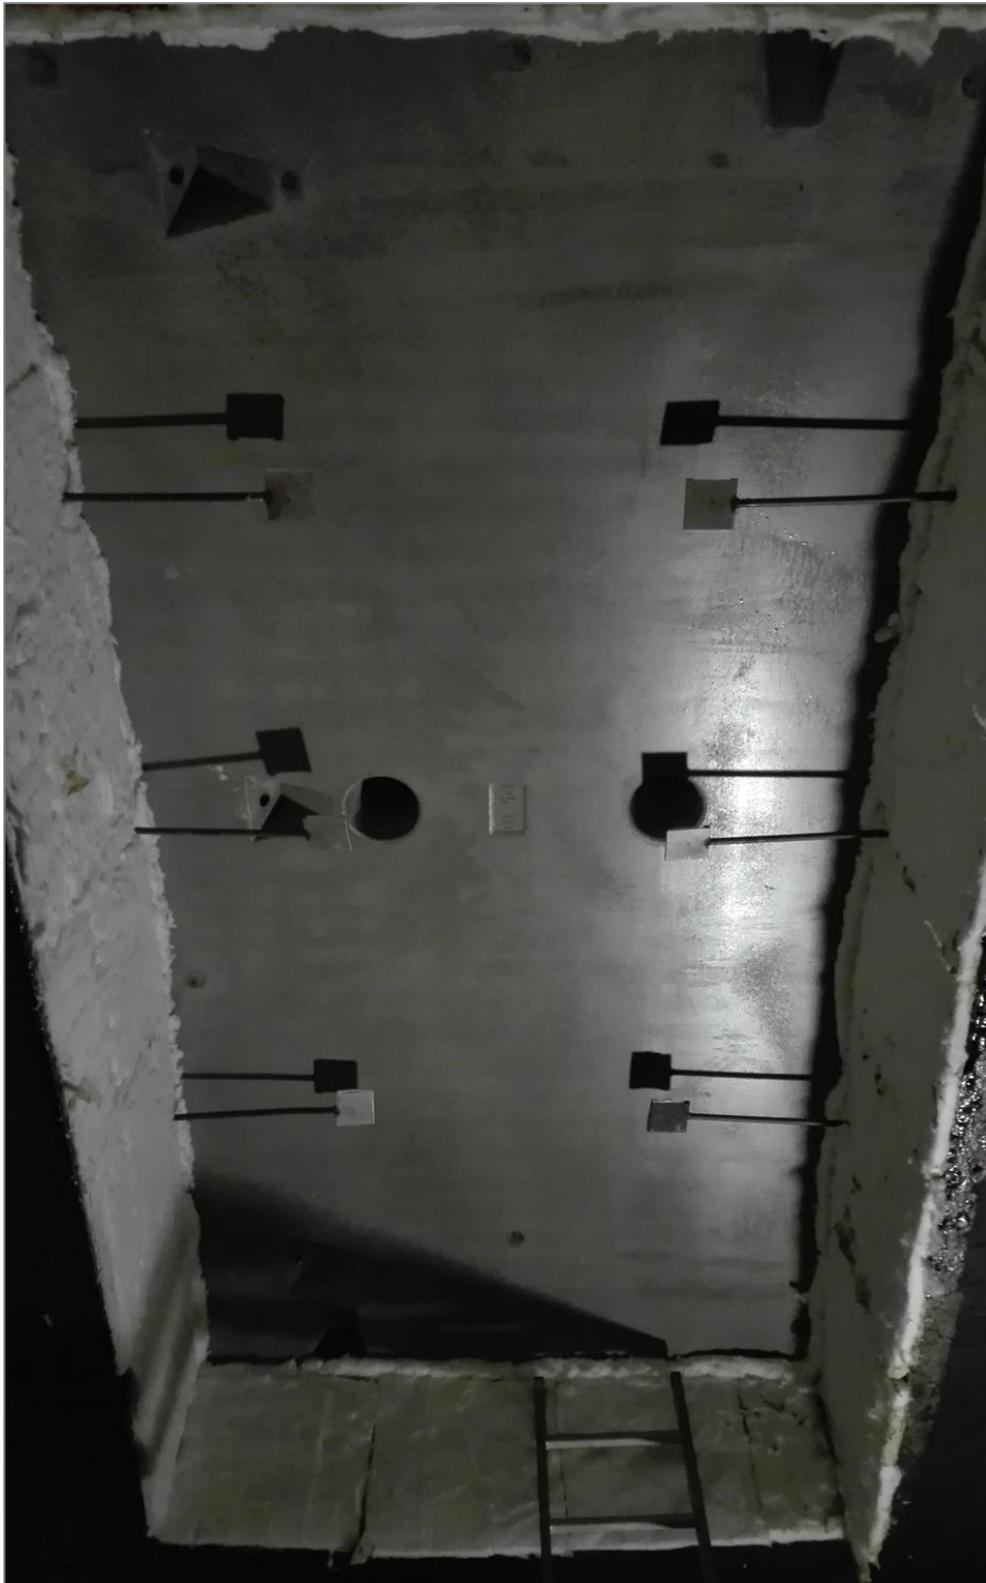
Thermal protection is alkaline earth metal-based material (Figure 17). Thickness is 25 mm.

Figure 17: View in the furnace of a single segment after applying thermal protection

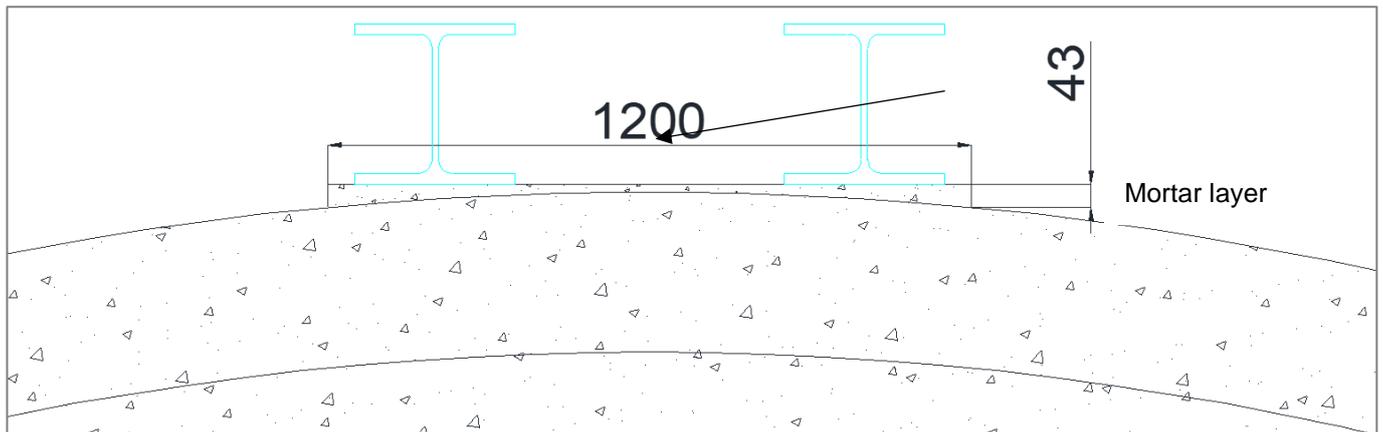
A mortar layer is applied on the top of the segment in order to obtain a flat and horizontal surface to load the sample. Geometry of the mortar layer are given in Figure 18.

Figure 18: Geometry of the mortar layer on the top of the segments in order to obtain a flat and horizontal surface to apply the vertical load

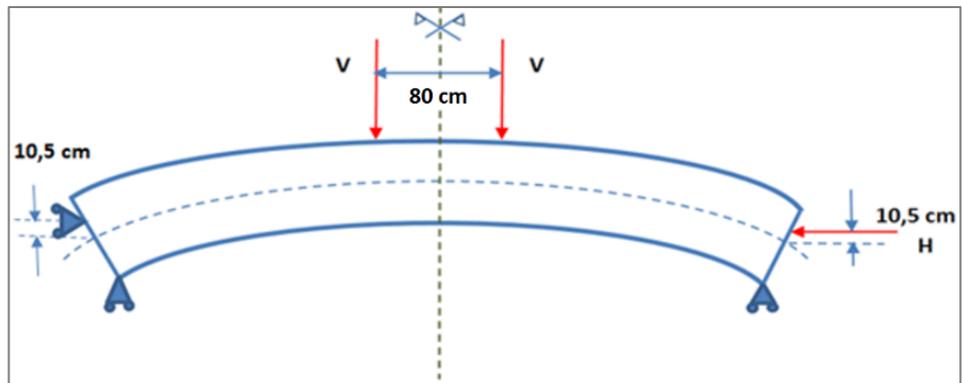
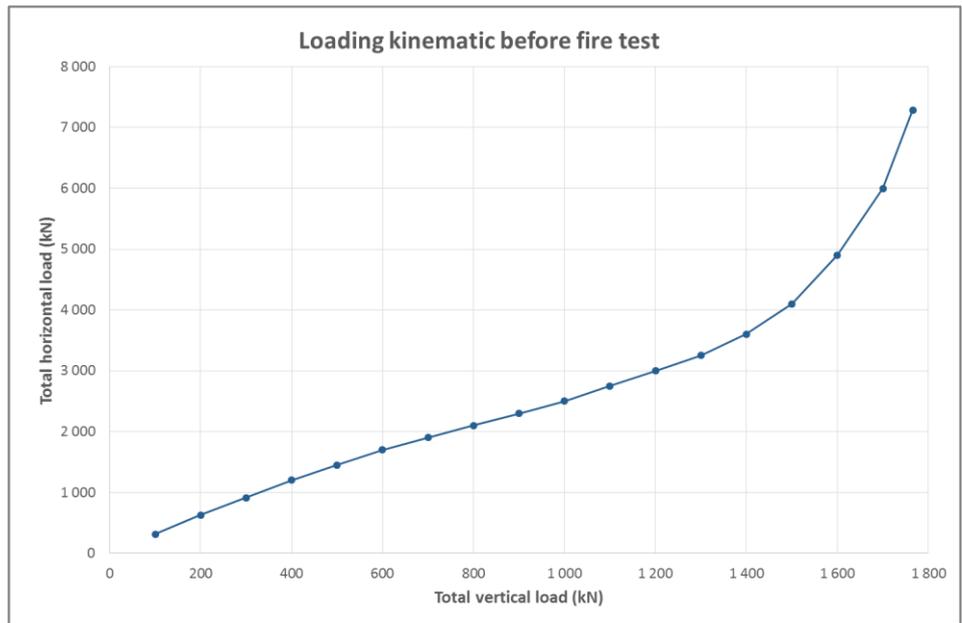
The horizontal and vertical loads increase successively during the loading phase following the values given in Figure 19. The mechanical loading kinematic before the application of the thermal load is as follows:

V	H
kN	kN
100	315
200	630
300	915
400	1 200
500	1 450
600	1 700
700	1 900
800	2 100
900	2 300
1 000	2 500
1 100	2 750
1 200	3 000
1 300	3 250
1 400	3 600
1 500	4 100
1 600	4 900
1 700	6 000
1 766	7 286

Figure 19: Loading kinematic before fire test

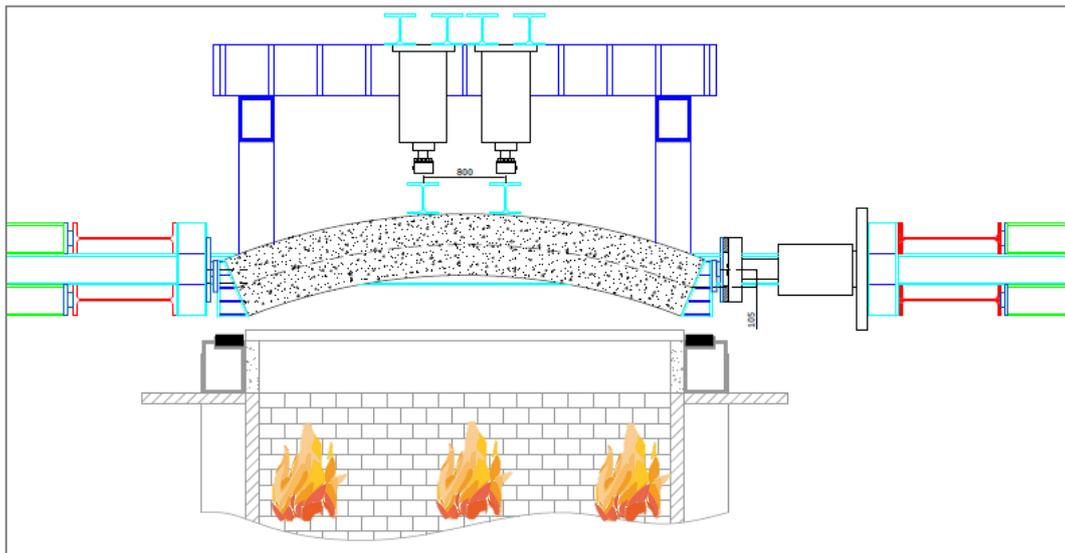
Segments are exposed to fire as described in the drawing in Figure 20.

Figure 20: Sample fire exposure

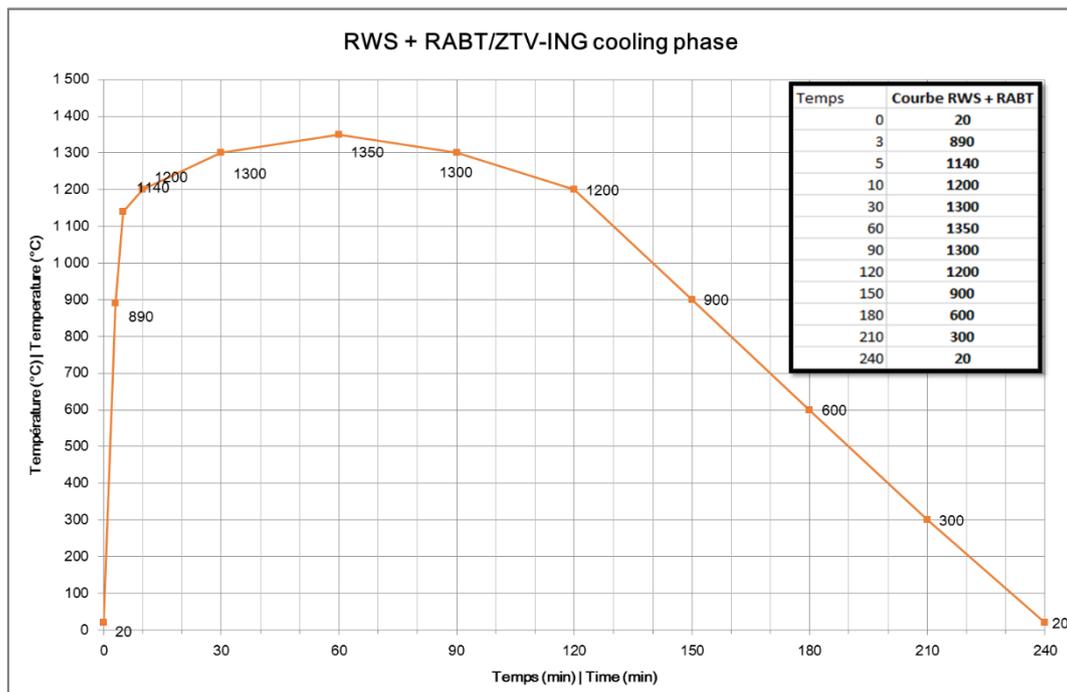
The followed temperature curve is given in Figure 21. The first 120 min of the fire exposure (ascending branch and the beginning of the descending branch) comply with RWS curve [7]. The final 120 min (descending branch) comply with the RABT/ZTV-Ing. curves.

Figure 21: Nominal fire exposure curve

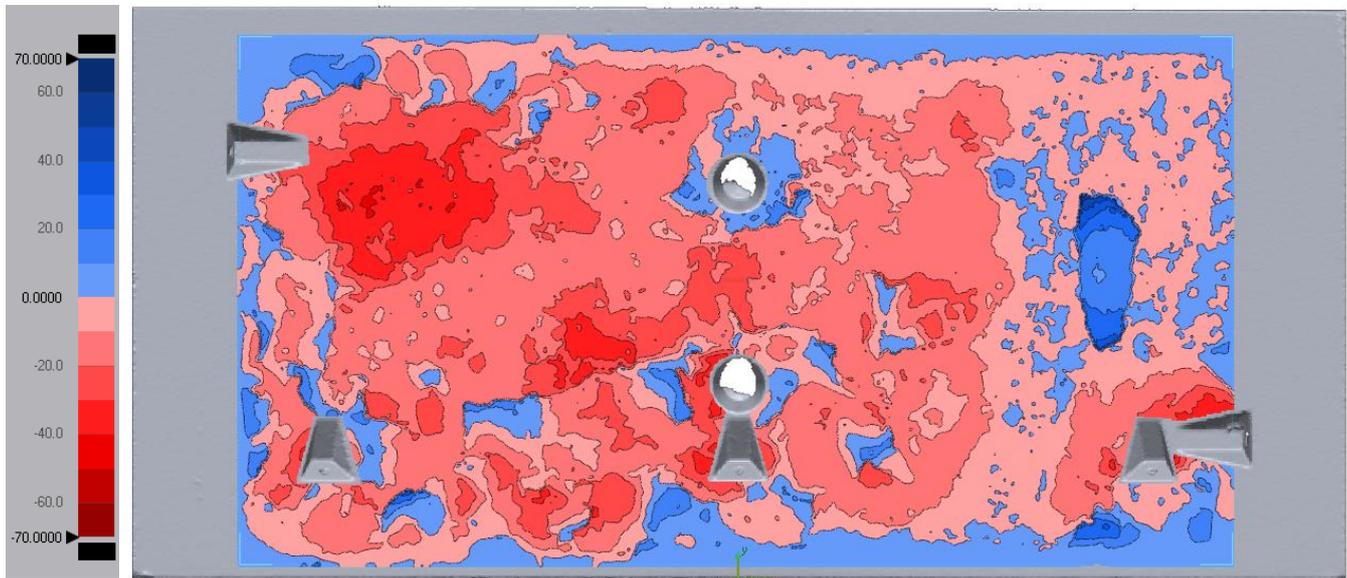
Spalling depth topographies are given in Figure 22 (after 2 hours) and Figure 23 (after 4 days). Measurements and pictures are given in appendix B pages 28 to 34.

In Figure 22, spalling depths are higher in 2 zones:

It is to be noted that part of the values is positive. This is explained first by the fact that in addition to the loss of concrete due to the spalling phenomena (negative values), the material expanded below the surface with partial detachment of concrete layers. Indeed, bumps were observed on the segment and voids were detected below the surface by hammering.

Figure 22 : Spalling depth field determined 2 hours after the test from 3D laser scanning. Values are given in mm

NOTE: The jacks are located on the left of the topography in Figure 22 and Figure 23.

As written before, in Figure 22, spalling depths are higher in 2 zones:

By considering that there were no expansion (no partial detachment) in these 2 areas and that the thickness of the fallen crust before the measurement was 8 mm, the spalling depth at the end of the fire test could have been between 22 and 30 mm and 12 and 18 mm respectively.

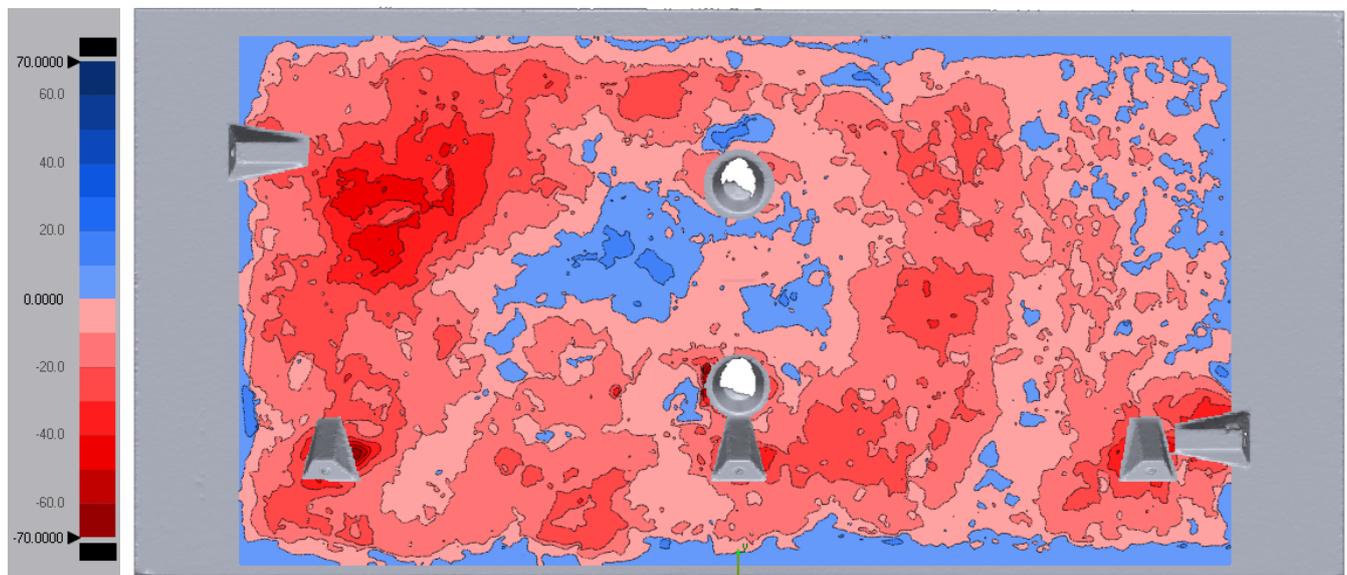
Figure 23 : Spalling depth field determined 4 days after the test from 3D laser scanning. Values are given in mm

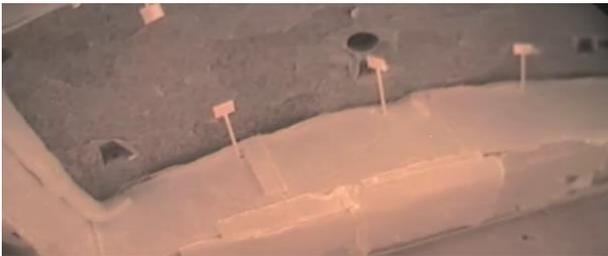
Picture 23 is a screenshot from the recorded video with one of the endoscopes after 8 min test. We can clearly observe in this the relief related to the spalling phenomena. Spalling depth is low. The reinforcement is not visible which means that spalling depth is lower than 50 mm. It is to be noted that, in the pictures from the endoscopes, the relief appears exaggerated at the beginning of the test.

Figure 24: Segment in the furnace during the fire test after 8 min taken with one of the 2 endoscopes

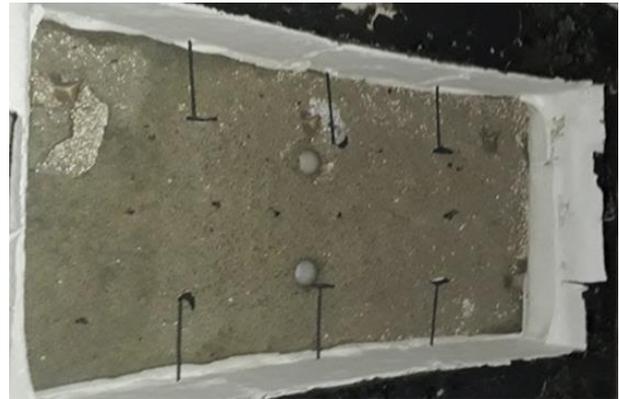
Spalling depth is quite homogeneous in the Figure 25, taken in the furnace just after the temperature cooling phase. We just can observe the fall down of a flake in the upper left corner of the picture.

Figure 25: Segment in the furnace after cooling down the temperature

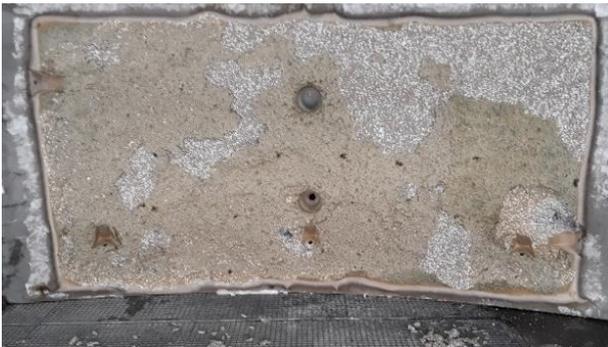
Large number of flakes has fallen down during handling the segment out of the furnace (Figure 26).

Figure 26: Segment just after being removed from the furnace

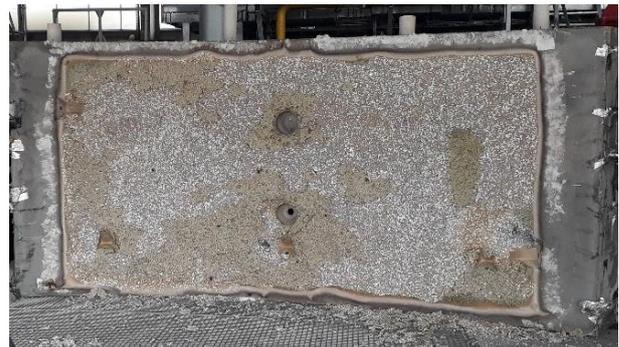
The phenomena continued until the 3D laser scanning (Figure 27). In this picture, most of the visible concrete at the end of the test has disappeared. Fallen concrete pieces are visible at the foot of the segment. The crust thickness was between 8 and 9 mm.

Figure 27: Segment 2 hour after being removed from the furnace during the 3D laser scanning

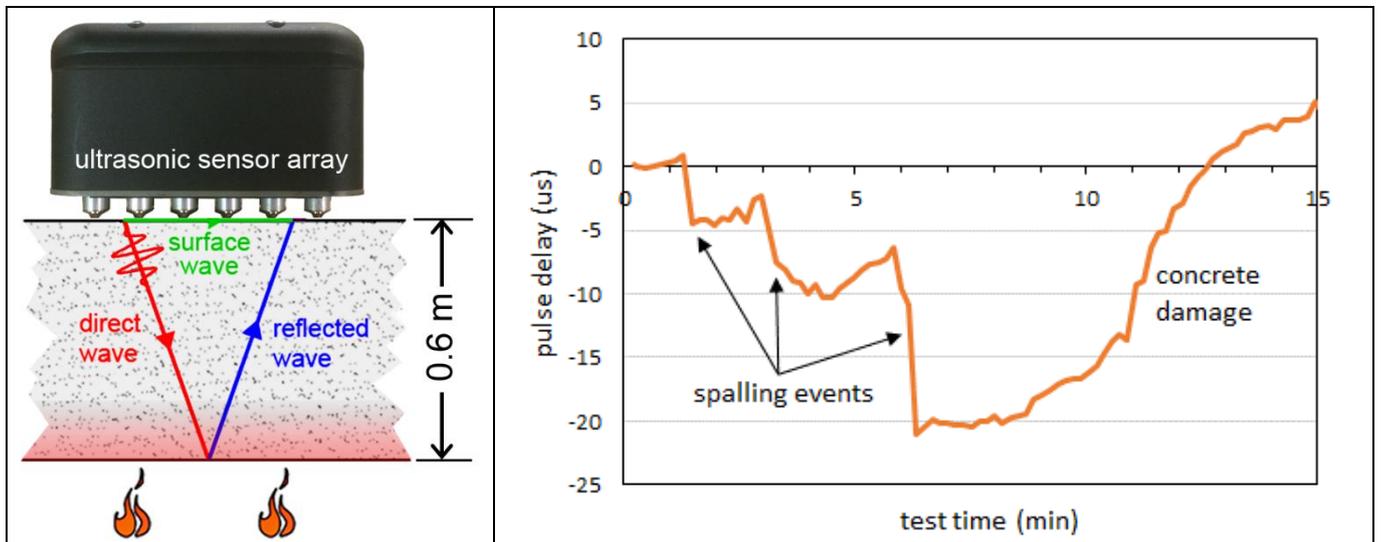
In order to allow the real-time monitoring of spalling progression during fire tests, the Ultrasonic Pulse Echo (UPE) technique was implemented by Felicetti and Lo Monte, 2016 [8]. The principle is to trigger very short ultrasonic pulses (1.5 cycles at 50 KHz) at the segment extrados and to detect the returning signal after complete back-reflection at the fire-exposed intrados (Figure 28). The total time of flight is governed by the combined effect of the element thickness and the material quality (pulse velocity). Concrete damage due to heating translates into a gradual increase, while spalling events lead to sharp reductions of propagation time. The method was implemented by means of a dry-point contact shear-wave sensor array (M2502 by ACS) fitted with a square wave pulser, a high gain amplifier and a digital scope. The sensor was installed in the central point of the segment and could monitor about 1 m² of the exposed intrados. The shift of propagation time was calculated based on the best cross-correlation between the current and the initial reflected echoes.

Figure 28: Ultrasonic Pulse Echo (UPE) technique principle (left) and pulse delay versus time (right)

The results show that three spalling events occurred in the first 6 minutes, leading to a total reduction of propagation time by 4.5, 10 and 21 microseconds (Figure 28). By considering the initial shear wave velocity (2.7km/s) and the expected material decay (average temperature in the detaching splinters ranging between 70 and 650°C) the corresponding total depths of spalling are 6, 13 and 21mm.
