Fire design of post-installed bonded rebars: Full-scale validation test on a 2.94 x 2 x 0.15 m ³ concrete slab subjected to ISO 834-1 fire

Fire design of post-installed bonded rebars: Full-scale validation test on a 2.94 x 2 x 0.15 m³ concrete slab subjected to ISO 834-1 fire

Keywords: Chemical post-installed rebars, Full-scale fire test, Cantilever slab-wall connection, Bond strength, Fire design method.

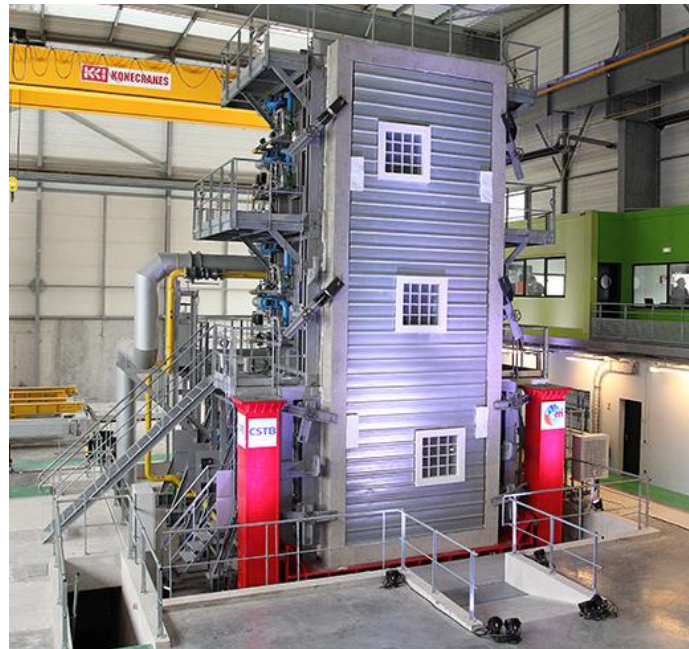
The full-scale fire test was carried out on the “Vulcain” modular gas furnace of CSTB Champs-sur-Marne, France (Fig. 3). The furnace offers three possible exposure areas to perform fire tests in the horizontal configuration: 3m x 3m, 4m x 3m and 7m x 3m. The fire test presented in this paper was performed on the 4 m x 3 m horizontal configuration. The test specimen configuration was composed of a concrete slab attached to a wall by post-installed rebars. The choice of this configuration can be justified by the fact that it could be representative of balconies maintained by chemical PIRs sealed into a concrete wall. The set-up of the test specimen on the furnace required the presence of a concrete frame allowing to close the furnace and to ensure its fire integrity during the test. The concrete frame was made from a C45/55 reinforced concrete containing propylene fibers, and represents the wall in which post-installed rebars are anchored. The configuration and dimensions chosen for the test specimen were a 2.94 m x 2 m x 0.15 m cantilever slab made from C20/25 reinforced concrete containing propylene fibers, connected to the wall by means of 8 post-installed rebars, bonded into concrete using an epoxy resin (Fig. 1). The number of PIRs was determined according to the EC2 part 1-1 design rules [29] which allow a maximum spacing between bonded rebars equal to two times the thickness of the slab (i.e. 300 mm). The diameter of the steel rebars was chosen equal to 16 mm and the embedment length was set at 135 mm. The thickness of the bond joint was equal to 2 mm, according to the resin supplier’s recommendations. A spacing of 80 mm at the sides and 200 mm at the free end of the cantilever slab was left to take into account the thermal expansion and the rotation of the slab, in order to prevent any possible blocking against the frame during the fire test (Fig. 4). The test specimen was mechanically loaded during the fire test with 325 kg dead weight positioned at 2200 mm from the wall, as shown in Fig. 1.

Fig.3 : Vulcain furnace of CSTB Champs-sur-Marne, France

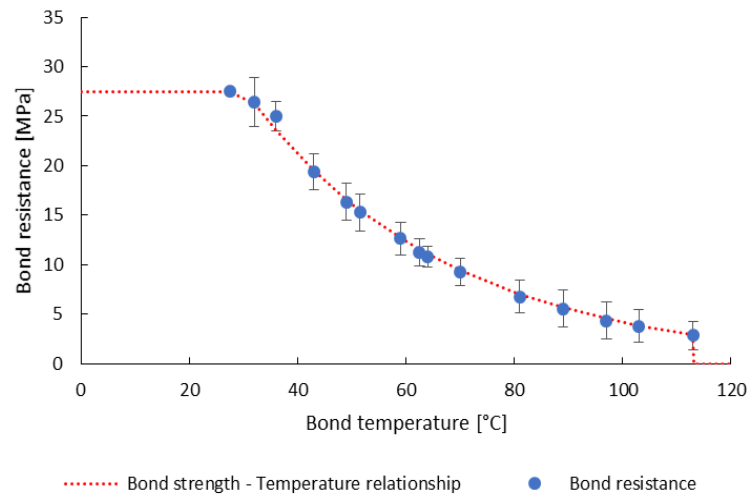
Eq. (9) represents the bond strength – temperature relationship. The bond resistance is assumed to be constant for temperatures below 27°C. The decay in the bond resistance under heating effect is described by an exponential law, which represents a good accuracy with experimental results ($R=0.998$). Above 115°C, the bond resistance is considered equal to zero.

Fig. 8: Bond strength - Temperature relationship determined by means of pull-out tests at constant load [23]

Using calculated thermal profiles (Fig. 7) and the bond strength-temperature relationship (Fig. 8), a bond resistance value is assigned to each element of the PIR at different times of fire exposure, according to its temperature. The predicted evolution of the bond resistance profile at different moments of fire exposure is shown in Fig. 9. Results show a constant bond resistance at the beginning of the fire test ($t = 0$ min) equal to 27 MPa, when the entire bond is at 20°C. As the temperature increases along the bond during heating, the bond resistance decreases progressively. The decay in the bond resistance is more significant at the beginning of the PIR than that at its end. This can be attributed to the important thermal gradient present along the embedded part of the steel rebars (paragraph 3.2.2). Therefore, the most resistant parts of the PIR are located at its end, where temperatures are relatively low. Thus, the thermal gradient leads to a new bond stress distribution along the PIR with a stress concentration in the coolest zones. By heating the slab, the temperature continues to increase along the PIR and therefore the bond resistance decreases. Calculations predict that after 180 minutes of ISO fire exposure, only 75 mm of the total bond length would resist to fire.

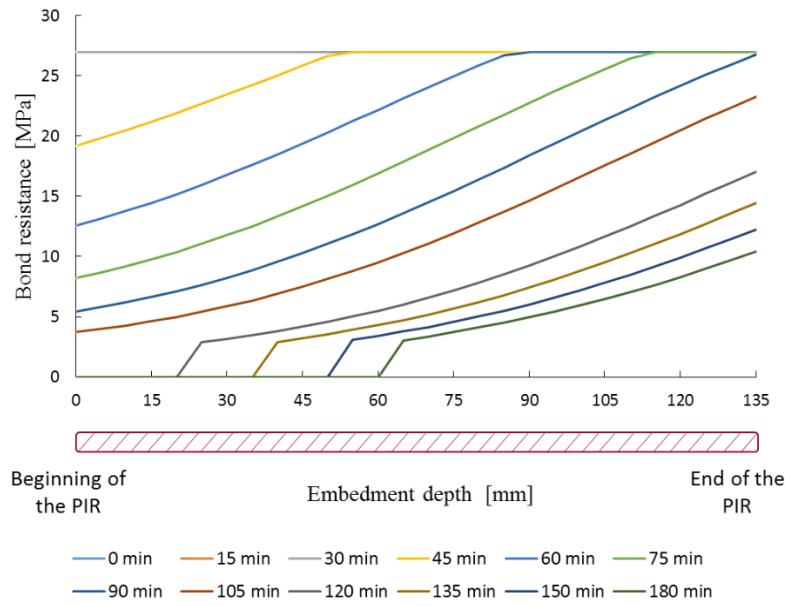
Fig. 9: Evolution of the PIR bond resistance during an ISO fire exposure

It is then possible to calculate the evolution of the load bearing capacity of the PIR, as described in paragraph 2, by the use of data from Fig. 9 and Eq. (4). Fig. 10 represents the evolution of the PIR load bearing capacity during the ISO fire exposure with margins of uncertainties resulting from the bond strength – temperature relationship (Fig. 8). The applied tensile load is represented in Fig. 10 by the horizontal lines, including the corresponding uncertainties (F_{\min} and F_{\max}).
